Technical Paper |
opticalCON® MTP® 24

Title: NTP08

Mechanical and optical tests applied to the opticalCON® transmission system for Pro Audio / Video industry purposes with main focus on changes in attenuation.

This documentation describes the results of the test series conducted at Neutrik AG and University of Applied Sciences of Technology Buchs NTB.

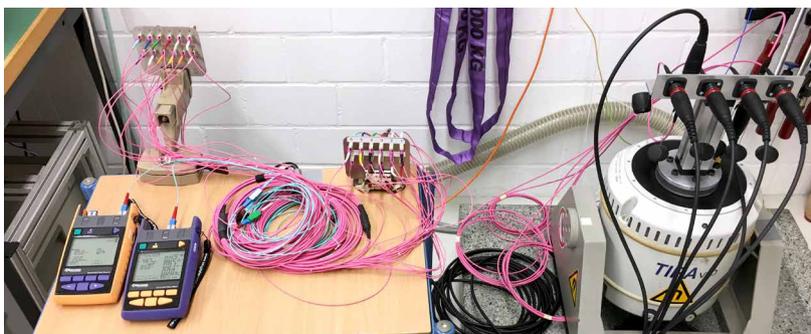
For the vibration test 6 receptacles NO24FDW-A were mounted. The front side was mated with a NKO24M-A-0-15 opticalCON MTP® cable. The rear end was connected with the test instrument via precision measuring cables (fig. 2.a).

Shaker:	Tira Power Amp. 5020	
Floor cloth:	Dytran 3136A (Serial Nr. 1313)	
Software:	SignalStar Vector (Version 2.3.989)	
Interface:	VL144x-R02	
Power Meter:	Kingfisher KI2824	
Light source (850nm):	Kingfisher KL2600GE	
Wavelength	850 nm	multimode
Frequency range:	10 – 55 Hz sinusoidal	
Amplitude displacement:	0.75 mm (1.5 mm p-p)	
Sweep rate:	1 oct/min	
Number of sweeps:	15	
Axis:	X, Y, Z

figure 1.a: Test set-up

After 15 cycles the receptacles were changed to the next axis without disconnecting the plugs to avoid any mismatching

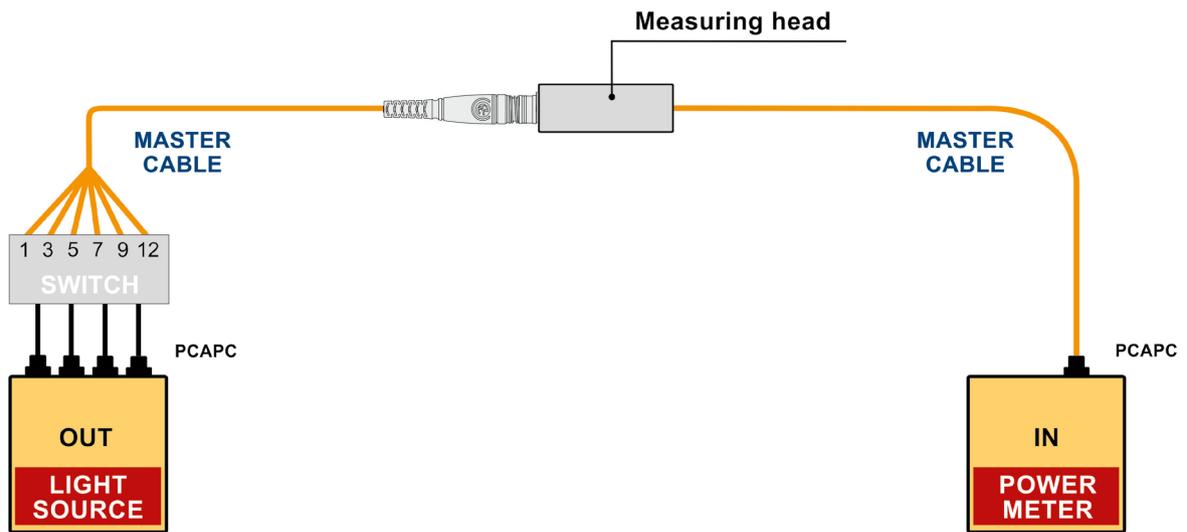
figure 1.b : reset to zero attenuation

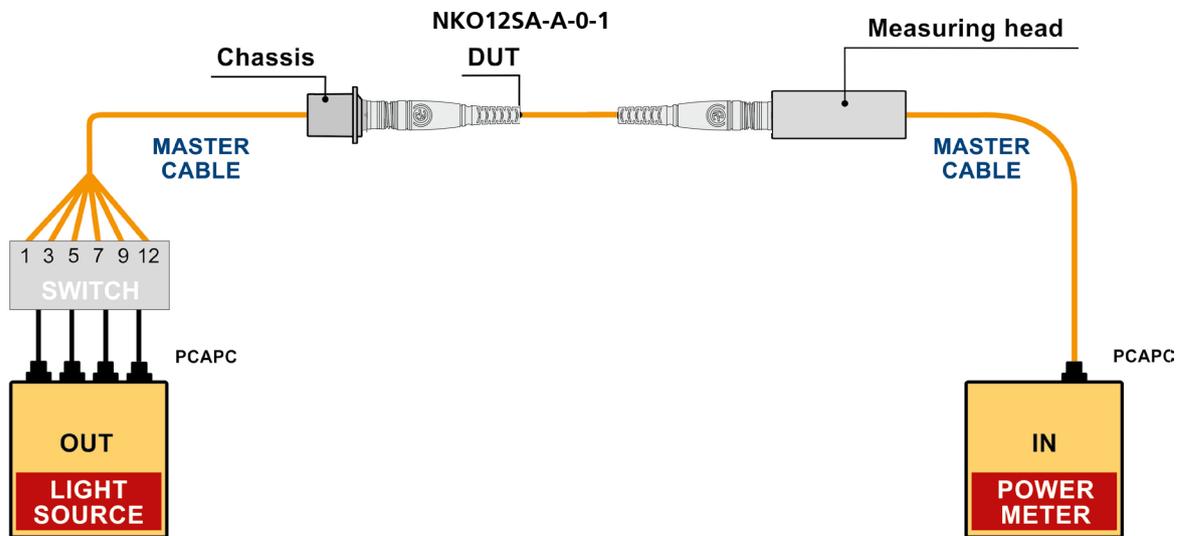
figure 1.c: Simplified measuring arrangement

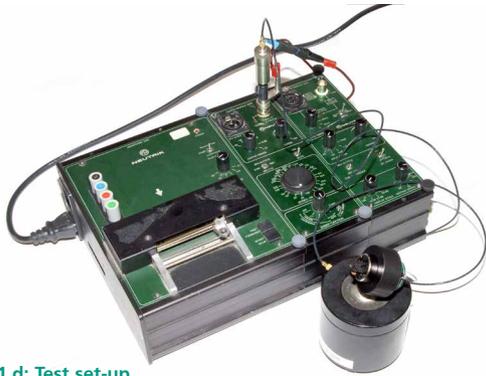
Examination of the sealing dust cover SCNO-FDW-A to analyze the performance and mechanical durability during defined vibration cycles.
 The applied test set-up complies with IEC 61300-2-1:2004.

figure 1.d: Test set-up

Shaker:	Brüel&Kjaer Mini Shaker Type 4810 and Neutrik Frequency Generator
Frequency range:	10 Hz – 18 kHz
Amplitude displacement:	1.75 mm (3.5 mm peak-peak) @ 40 Hz
Test components:	NO12FDW-A (opticalCON MTP® chassis) SCNO- FDW-A (sealing dust cover)
Axis:	X, Y, Z

No reasonable mechanical degradation of the sealing dust cover during and after vibration test.

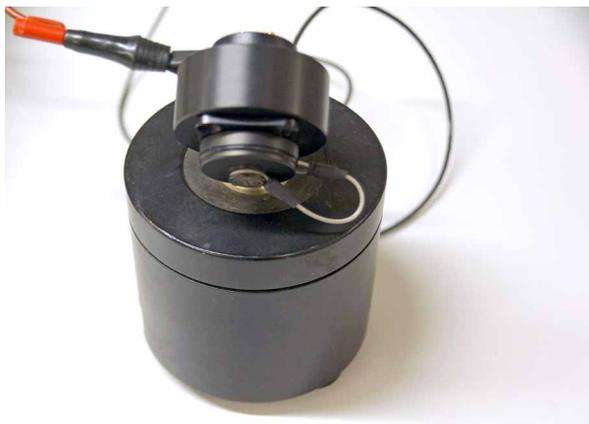
figure 1.e: Front side of shaker

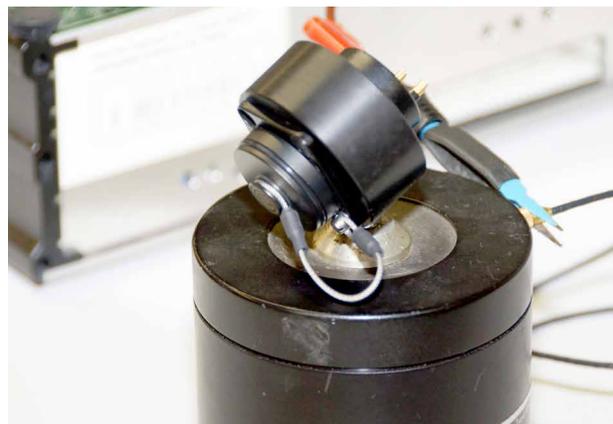
figure 1.f: Side view of shaker

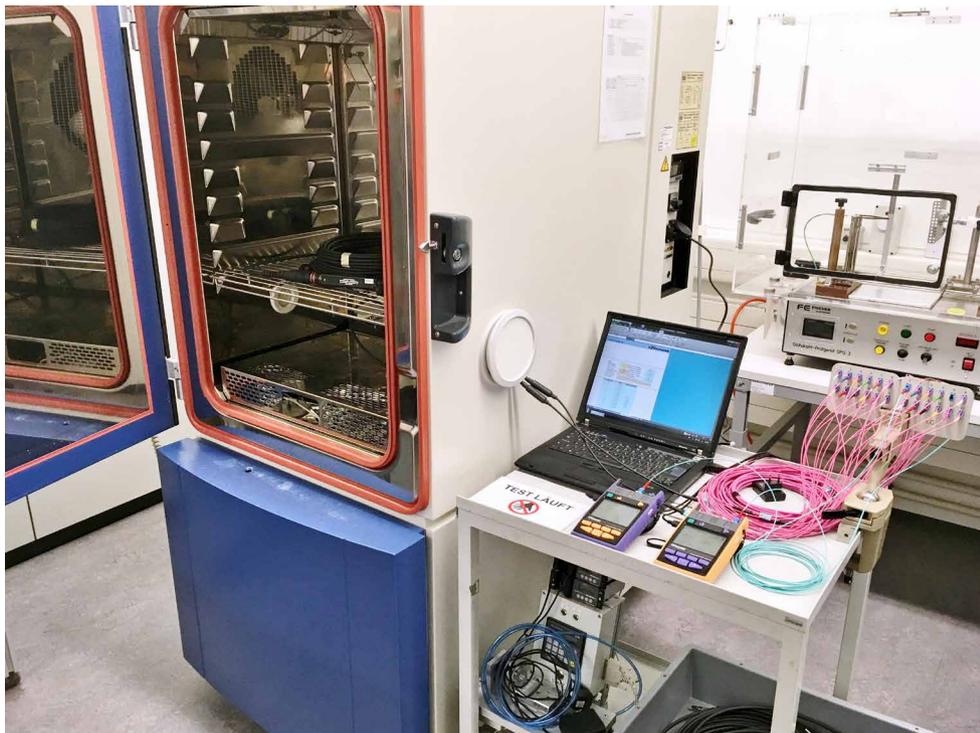
The test was realized in a temperature testing chamber type WEISS WK11-180/40.

Test cycles:	96 h	
Profile of temperature:	-25 °C to +70 °C	
Light source:	Kingfisher KI2824	
Power meter	Kingfisher KI2600GE	
Launching cables:	0.9 mm precision fibres	
Measuring wave lengths:	850 nm	multi mode
Cable length:	15 m

figure 2.a: Test set-up

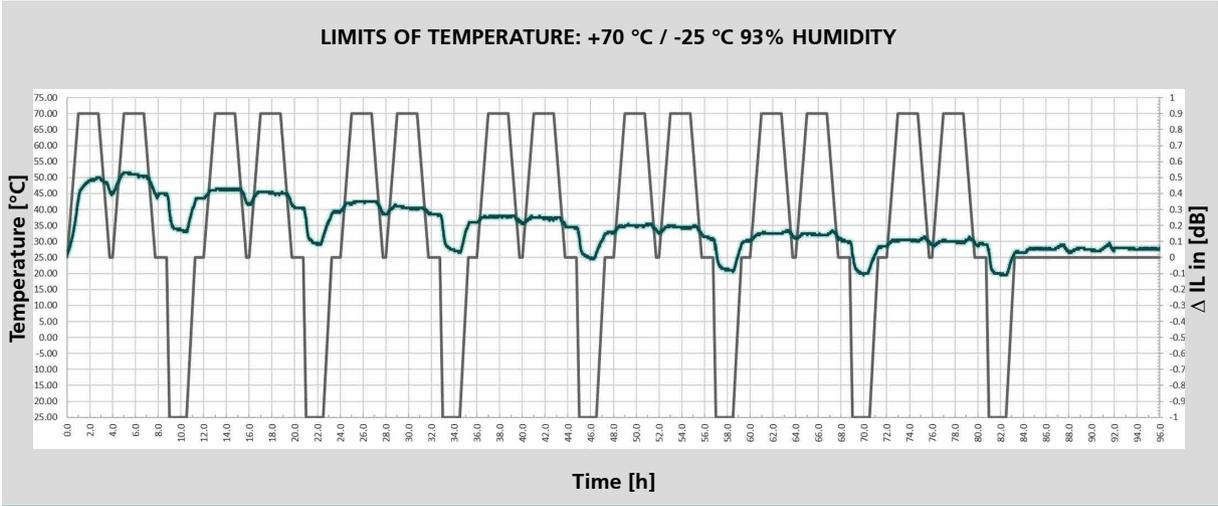
figure 2.b: Temperature profile and measurement results

The change of the attenuation over four fibers and eight connections varied from 0.1 dB to maximum 0.6 dB within 96 hours. The values are in the Neutrik’s attenuation and return loss limits and for field application with temperature variations suitable.

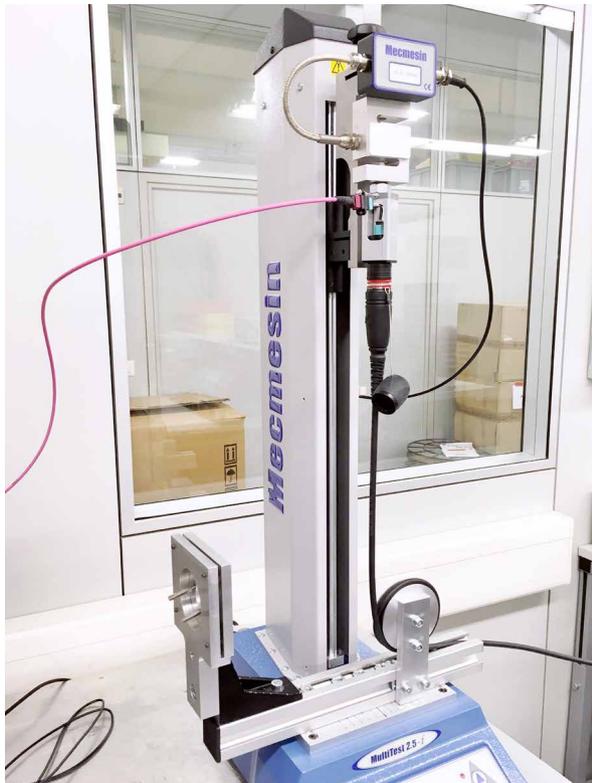
Tension test device:	Mecmesin MultiTest 2.5i (0 - 1'000 N)
Light Source:	Kingfisher KI2824
Power Meter:	Kingfisher KI2600-GE
Cable type:	NKO24M-A-0-15

figure 3.a: Test set-up

The opticalCON MTP® cable is tested and approved for min. 600 N and 60 sec. readjustment without any quality and function adverse effects.

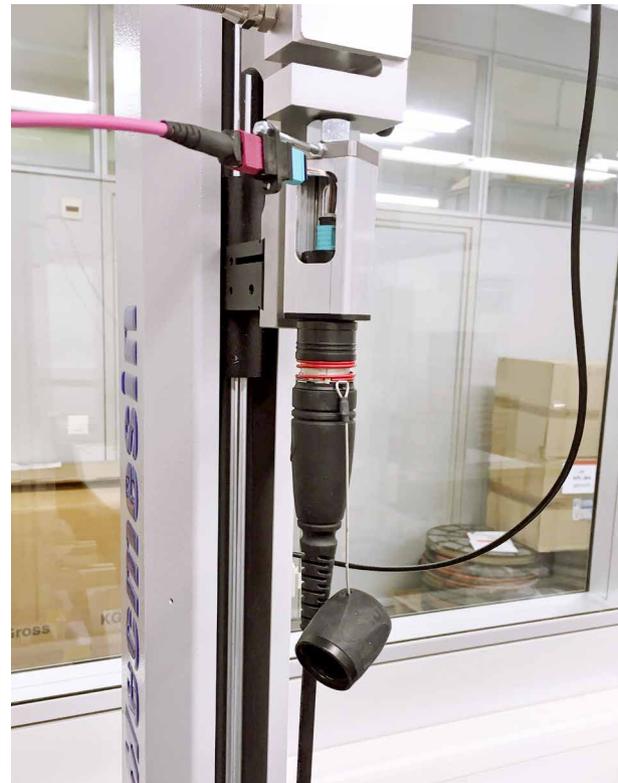
figure 3.b: Detailed measuring set-up

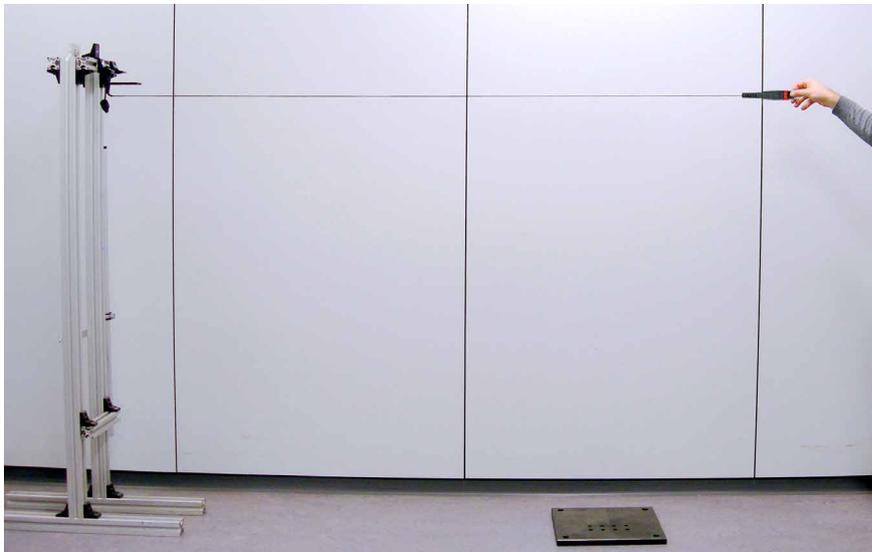
Distance from centre of rotation:	2.25 m
Number of drops:	5
Height of falling:	1.0 – 1.9 m
Ground:	steel plate, thickness 25 mm
Plug fixation:	small wire

figure 4.a: Test set-up "Impact"

Impact test with different heights (1.0 - 1.9 m) and steel plate.

After several impact tests on different heights (1.0 - 1.9 m) the opticalCON MTP® 24 connector doesn't indicate any visual abrasion or mechanical damages.

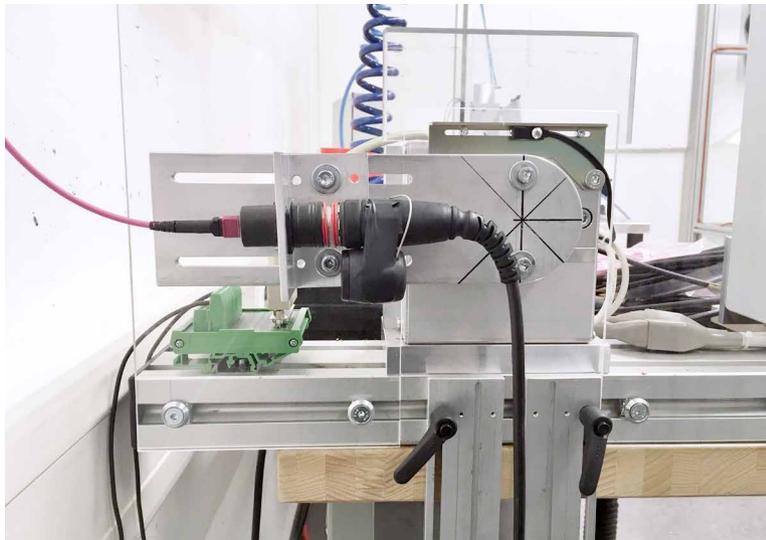
Test cycles:	10'000
Mass of weight:	10 N
Flexing angle:	$\pm 90^\circ$
Flexing speed:	ca. 37 cycles/min
Light source:	Kingfisher KI2824
Power meter:	Kingfisher KI2600-GE
Launching cables:	0.9 mm precision fibers
Wavelength:	850 nm
Test cable:	NKO24M-A-0-15

figure 5.a: Test set-up

- a) Change in attenuation over all 24 multi mode Fibers < 0.20 dB
- b) Mechanical cable damage at 10'000 cycles: no damage

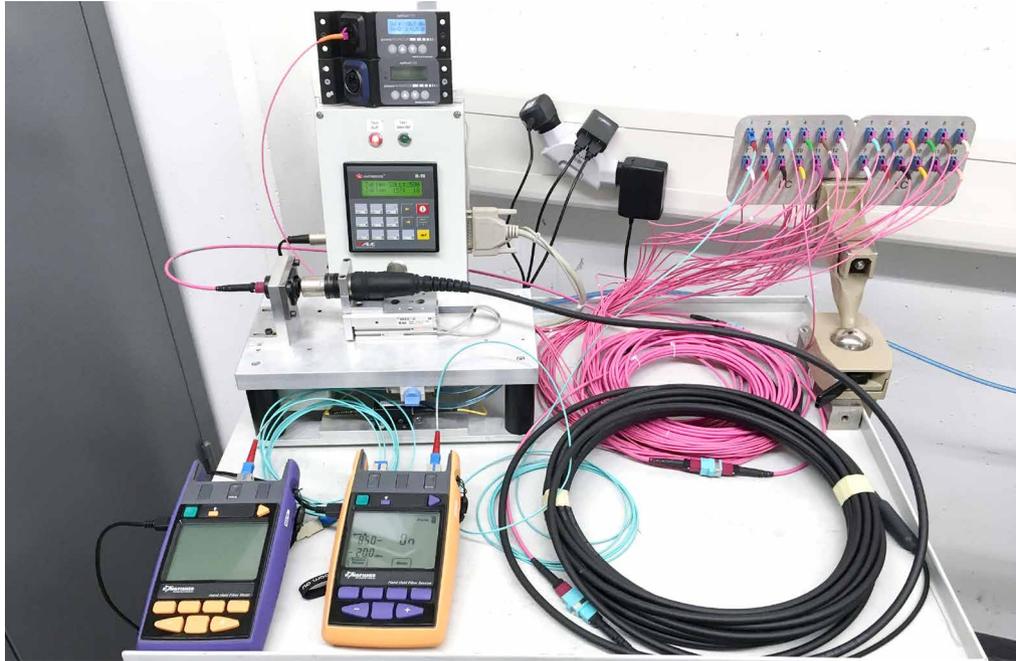
Mating cycles:	2'500	
Launching:	Kingfisher KI2824	light source
	Kingfisher KI2600-GE	power meter
Microscope:	enlarged x 200	
Measuring cables:	0.9 mm precision fibres	
Measuring wave lengths:	850 nm	multi mode
DUT cable length:	15 m	multi mode

figure 6.a: measuring setup for lifetime test

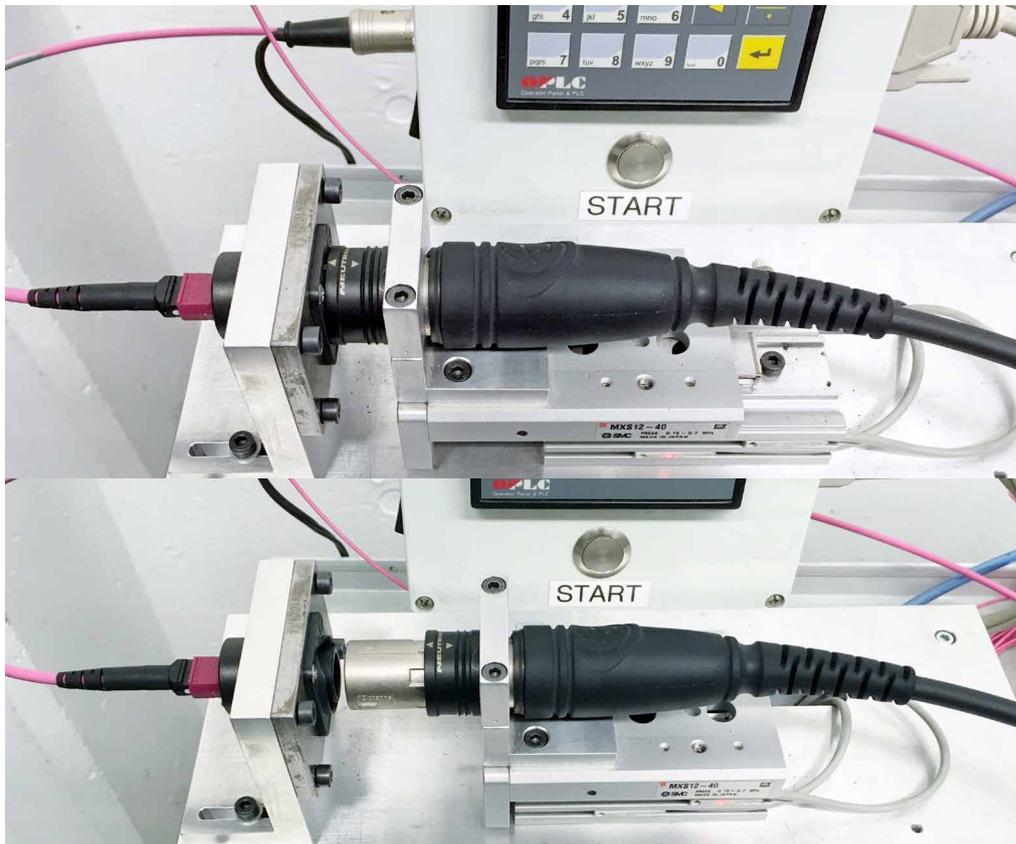
figure 6.b: fixture for 2'500 mating cycles

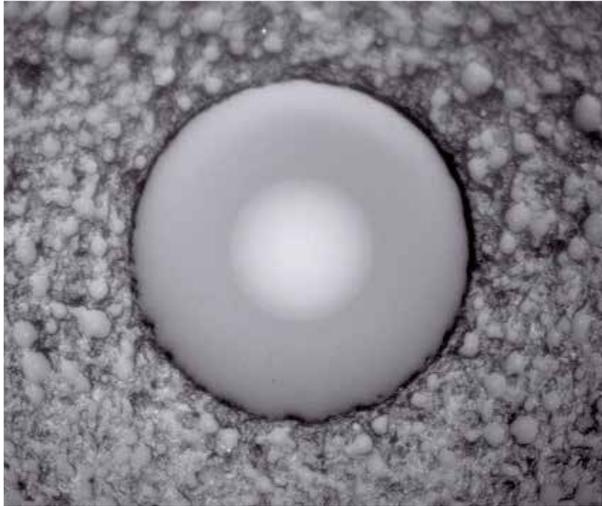
figure 6.c: Fiber condition before test

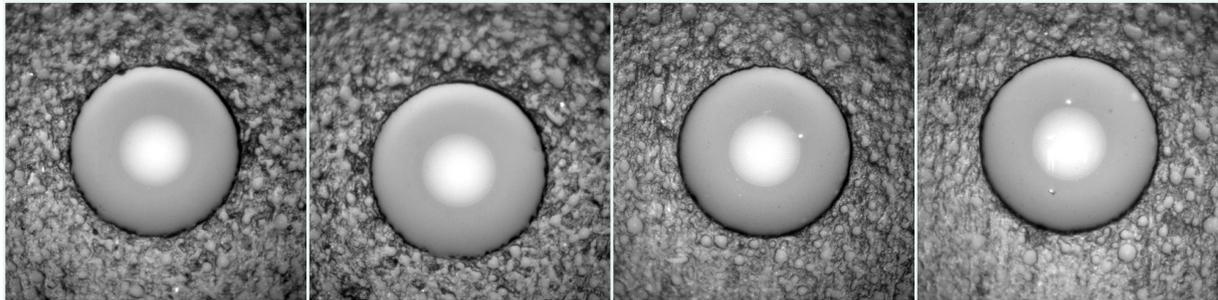
figure 6.d: Fiber condition after test

- no visual degradation on all channels.
- no recenable soil remains or scratches.

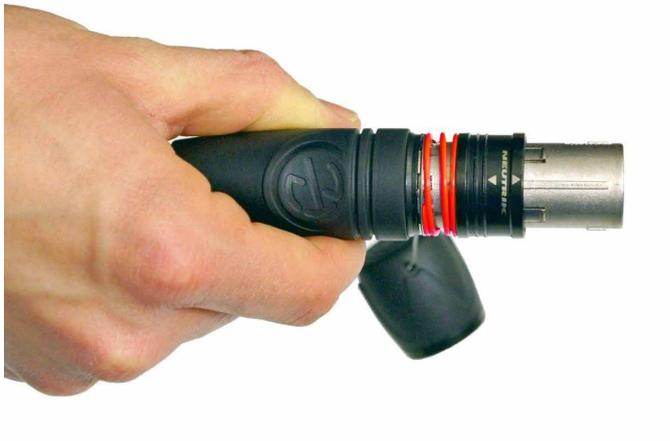
figure 6.e: MTP® 24 cable connector after test

No mechanical degradations on the opticalCON MTP® cable connector and proper functionality of the shutter and locking mechanism.
