**Technical Paper |**  
**opticalCON® MTP®**

**Technical Paper – opticalCON MTP®**

Title: NTP06

Mechanical and optical tests applied to the opticalCON® transmission system for Pro Audio / Video industry purposes with main focus on changes in attenuation.

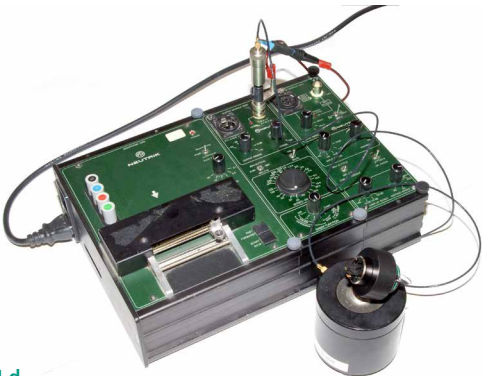
figure 1.d

Examination of the sealing dust cover SCNO- FDW-A to analyze the performance and mechanical durability during defined vibration cycles.  
 The applied test set-up complies with IEC 61300-2-1:2004.

Shaker:	Brüel&Kjaer Mini Shaker Type 4810 and Neutrik Frequency Generator
Frequency range:	10 Hz – 18 kHz
Amplitude displacement:	1.75 mm (3.5 mm peak-peak) @ 40 Hz
Test components:	NO12FDW-A (opticalCON MTP® chassis) SCNO- FDW-A (sealing dust cover)
Axis:	X, Y, Z

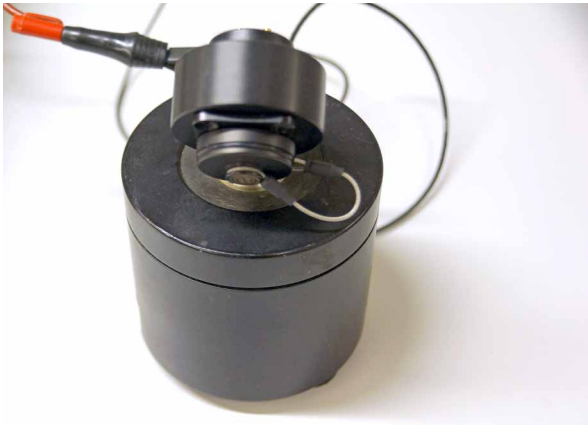
figure 1.e

No reasonable mechanical degradation of the sealing dust cover during and after vibration test.

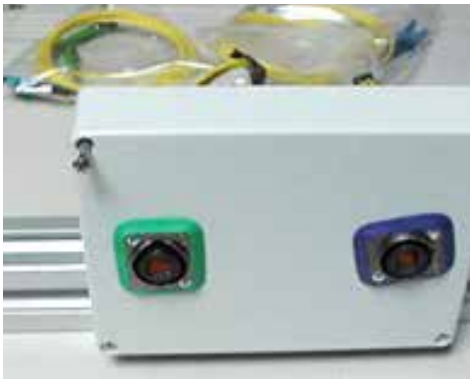
figure 2.a

Figure 2.a and 2.b exhibit two opticalCON chassis NO12FDW-A with silicon gaskets SCDP\*. On the rear side there are standard single-mode LC/LC patch cables plugged. To avoid dust on the ferrules, the unconnected LCs are sealed with a plastic bag.

After dust test: The opticalCON MTP® chassis NO12FDW-A are completely covered with talcum particle on the front and rear side (fig. 2.a ). The measured attenuation (figure 2.b) establishes only small variation of the attenuation values after dust test.

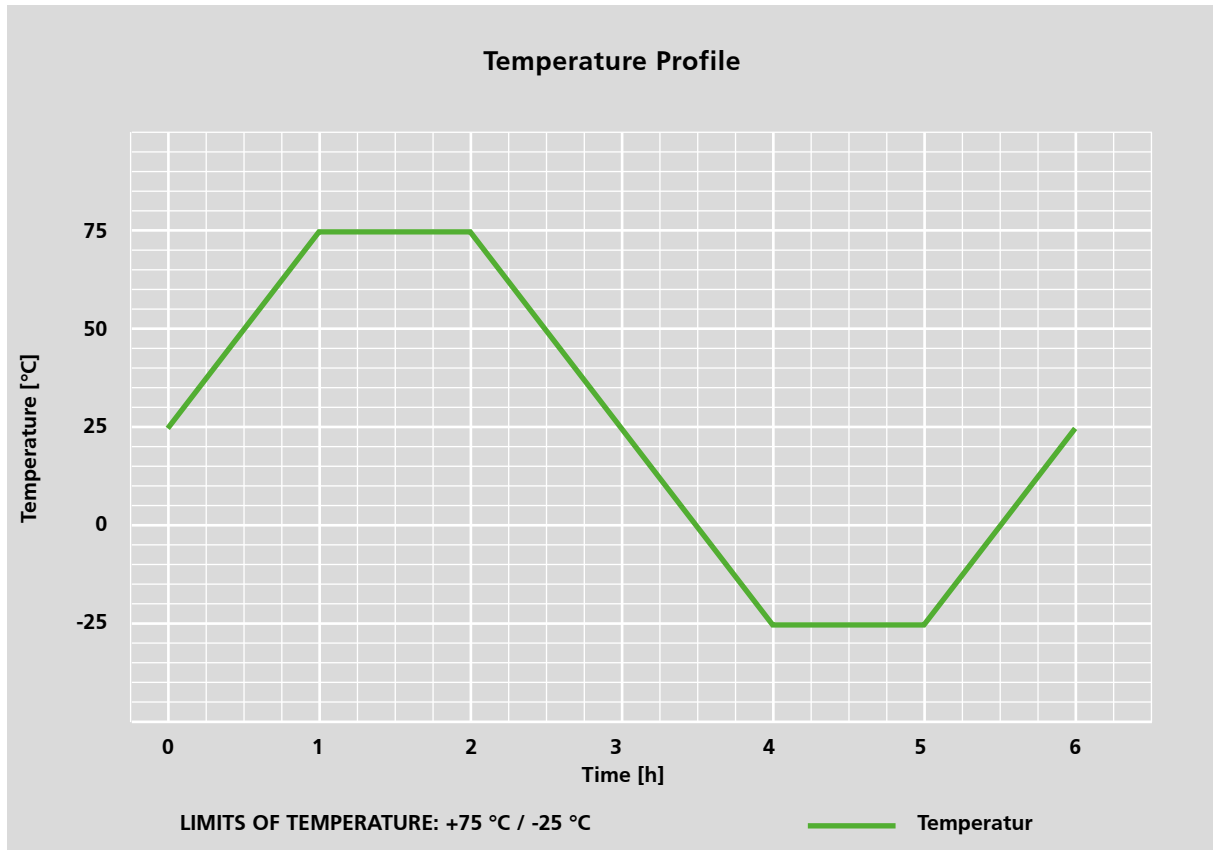
figure 3.b: Increase of the IL due to temperature change

The attenuation varied from 0.11 dB to maximum 0.35 dB within 24 hours. The values are in the Neutrik's attenuation and return loss limits and so for field application with temperature variations suitable.

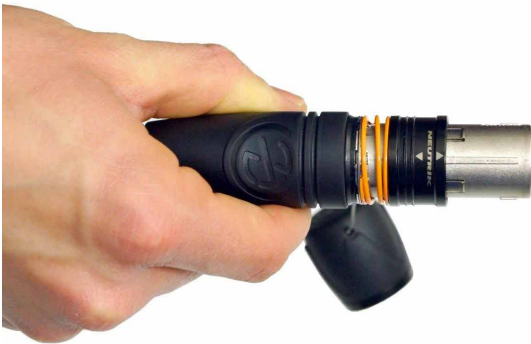
figure 7.g

No mechanical degradations on the opticalCON MTP® cable connector.

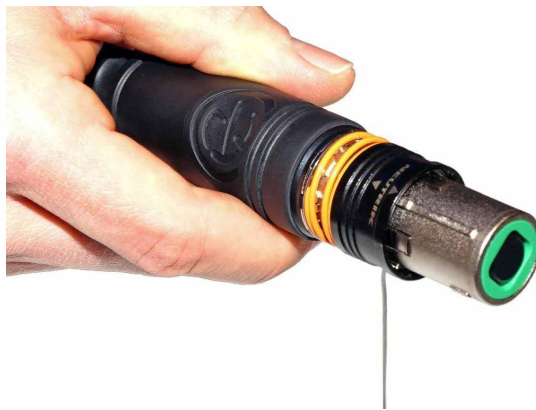
figure 7.h

Proper functionality of the shutter and locking mechanism.

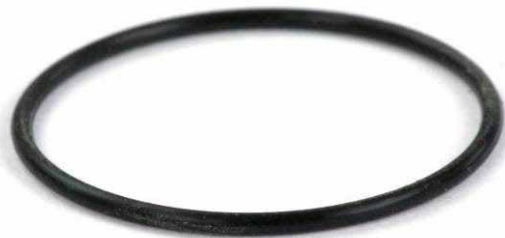
figure 9: O-ring after 2.500 mating cycles

After 2.500 mating cycles and temperature test the opticalCON chassis NO12FDW-A (figure 14) didn't show any significant deformations or mechanical malfunction. The greased O-ring didn't indicate any cracks or rough areas (figure 15).
